**Risk Management Division**

Subject: Policy Number MWC 117528-12

On Wednesday January 9, 2013, I visited the Erie County Technical School to perform a safety inspection of your buildings and grounds. Mr. Thomas Giblin of Wagner Giblin Insurance was also in attendance.

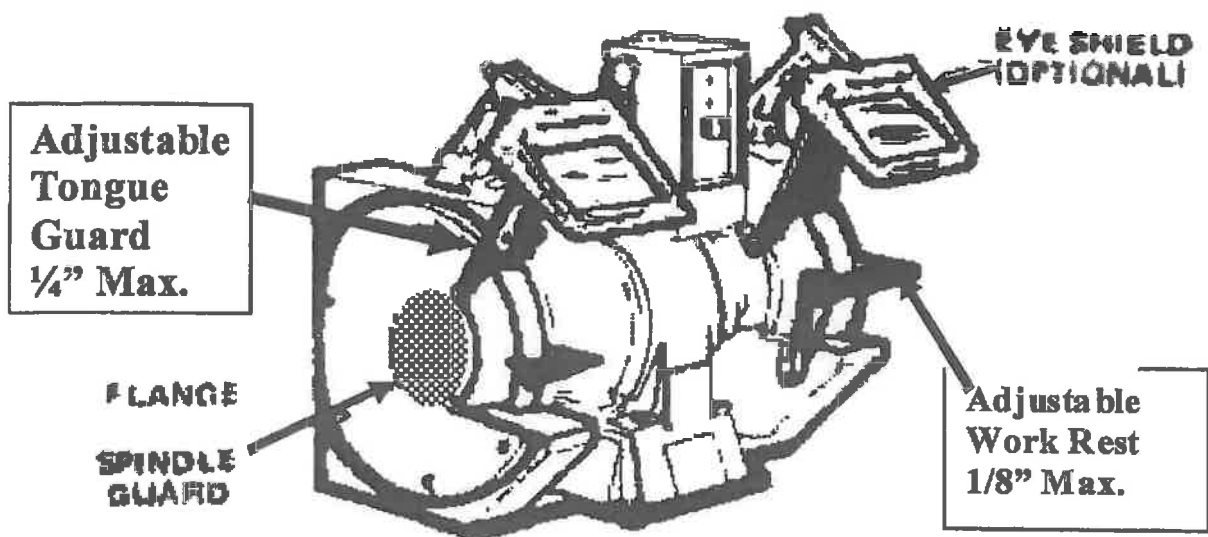
- 13-10 There was no tongue guards on the bench grinder located in the weld shop. Tongue guards should be installed to prevent the operator from being struck by sparks or other grinding debris, causing personal injury. As the grinding wheels wear, the tongue guards must be adjusted to within ¼ inch to the grinding wheels to provide adequate protection. Refer to the bench grinder diagram on the last page for an illustration of this guard.

The tongue guards have been installed in accordance to the bench grinder diagram provided with the insurance recommendations.
