**ERIE COUNTY TECHNICAL SCHOOL  
AGENDA ITEM**

**SUBJECT:** Chimney Demolition

Northwest Restoration, Inc. performed a complete survey of the chimney stack located at the Erie County Technical School on October 9, 2014. A 60' manlift was utilized to access the stack on all elevations. A thorough inspection was performed and loose material was removed from the veneer course of brick. At the same time, an inspection hole was created to determine the composition of the interior wythes of brick.

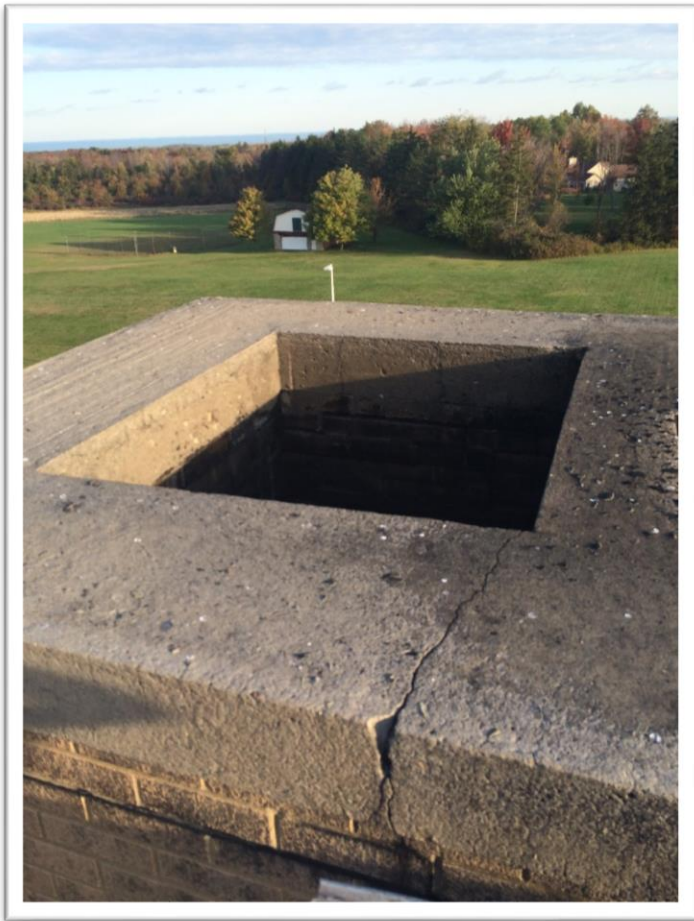
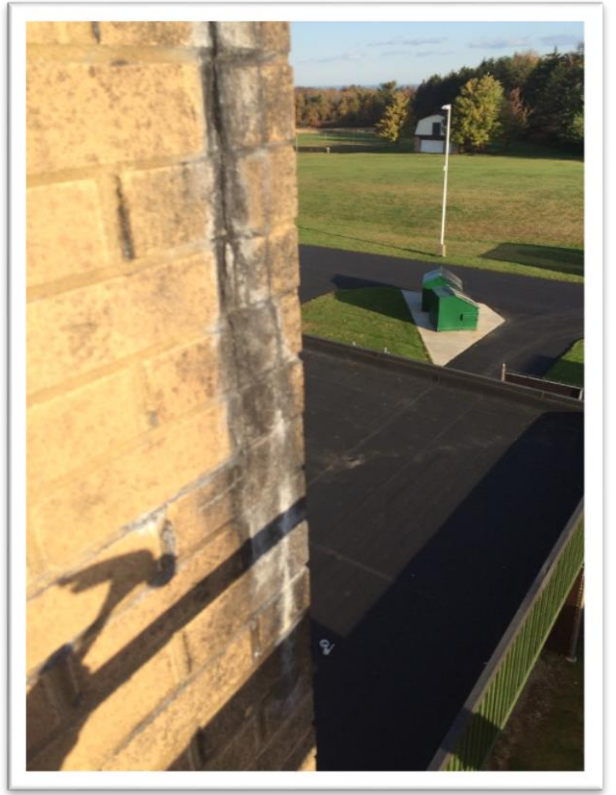
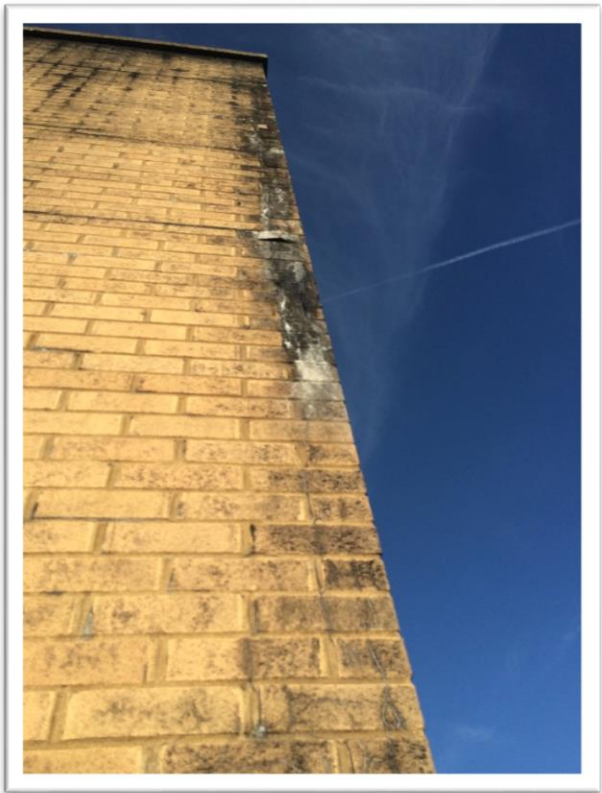
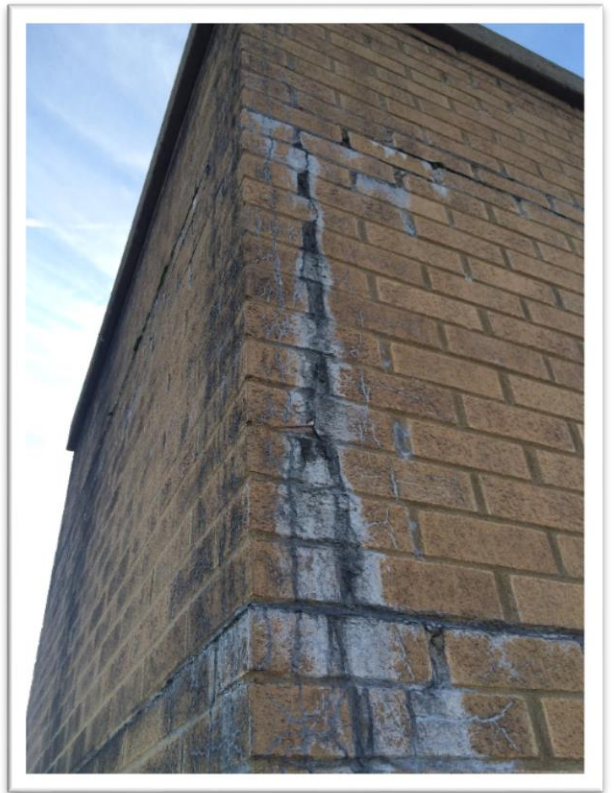
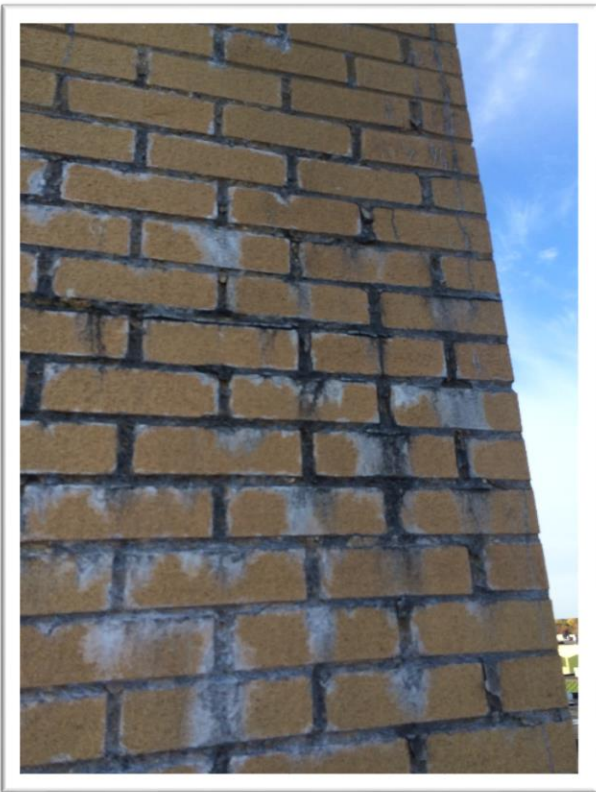
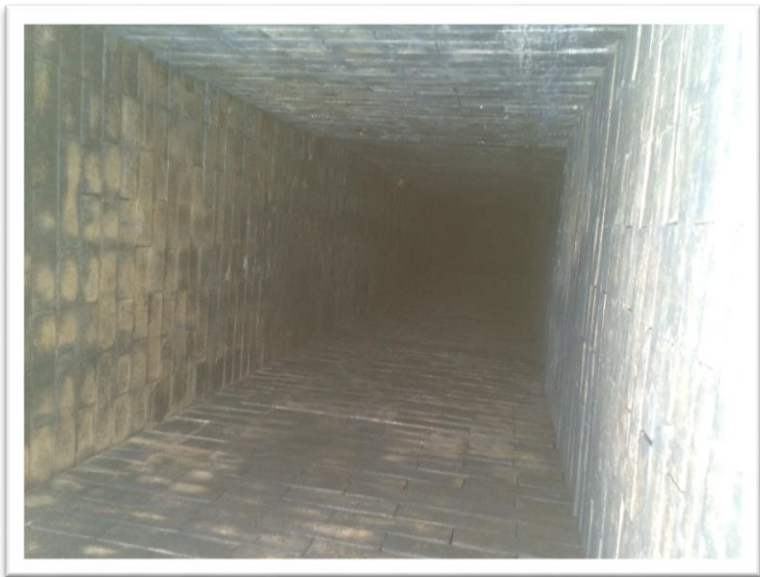
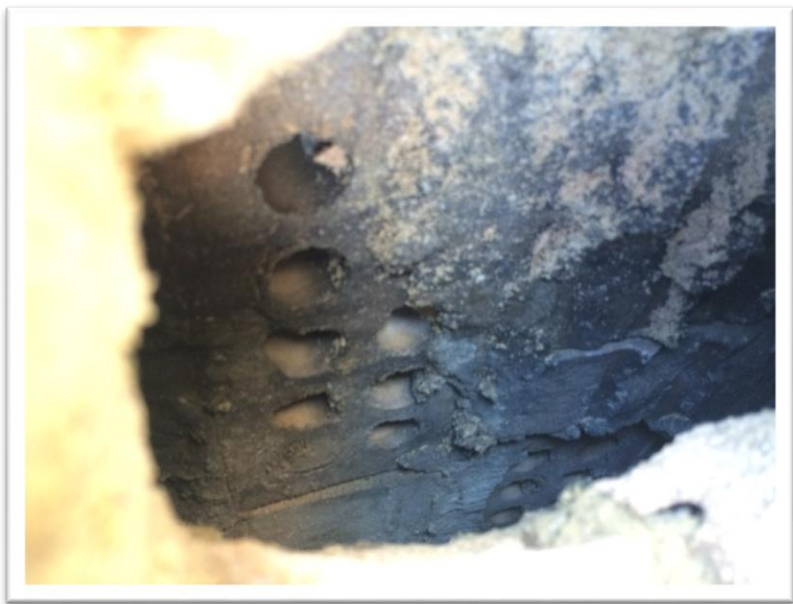
Deterioration of the chimney has progressed to the point where the risk of brick and other parts falling off could be hazardous to students in the courtyard. See attached reports and photos.

Northwest Restoration (NWR) determined the cause for the efflorescence, brick spalling and mortar joint failure to be a combination of condensation from inside the stack and water intrusion on the exterior. It was found that the boilers and hot water heaters of the building vent into the stack. This introduces moisture into the stack from the vent gases. The interior liner, while structurally stable, allows this water vapor to pass through the interior masonry into the cavity between the interior brick and exterior brick. The middle wythe of masonry appears to be a "slush" wall with brick laid on the sides. This is common in older construction, but allows the moisture to permeate to the cavity between this wall and the exterior veneer brick, where it begins to deteriorate the brick from the inside out due to the freeze thaw cycle and seasonal variations in temperature. As the moisture escapes through the veneer brick, it causes efflorescence along with brick and mortar failure. In addition, once cracks form in the exterior veneer courses, it allows for water intrusion from the outside, further deteriorating the masonry.

Although the material in immediate danger of falling was removed, there is nothing stopping the moisture from continuing to deteriorate the masonry and causing more failure due to boiler and hot water use, especially during the winter months. It is recommended restoration of the stack be completed within the next year as follows:

- Determine if the stack can be lowered according to building code and demolish down to that level.
- Strip the remaining veneer course of brick down to ground level due to extent of deterioration.
- Repair middle wythe of brick as necessary.
- Install new brick veneer.
- Install stainless steel insulated flue liner to prevent moisture into the masonry.
- Install a new concrete cap.
